MISCELLANEOUS PAPER SL-81-1

**CONCRETE AND ROCK TESTS
MAJOR REHABILITATION OF DRESDEN ISLAND
LOCK AND DAM, ILLINOIS WATERWAY
CHICAGO DISTRICT, PHASE II COMPLIANCE
SCOUR DETECTION**

R. L. Stowe, B. A. Pavlov

March 1981
Final Report

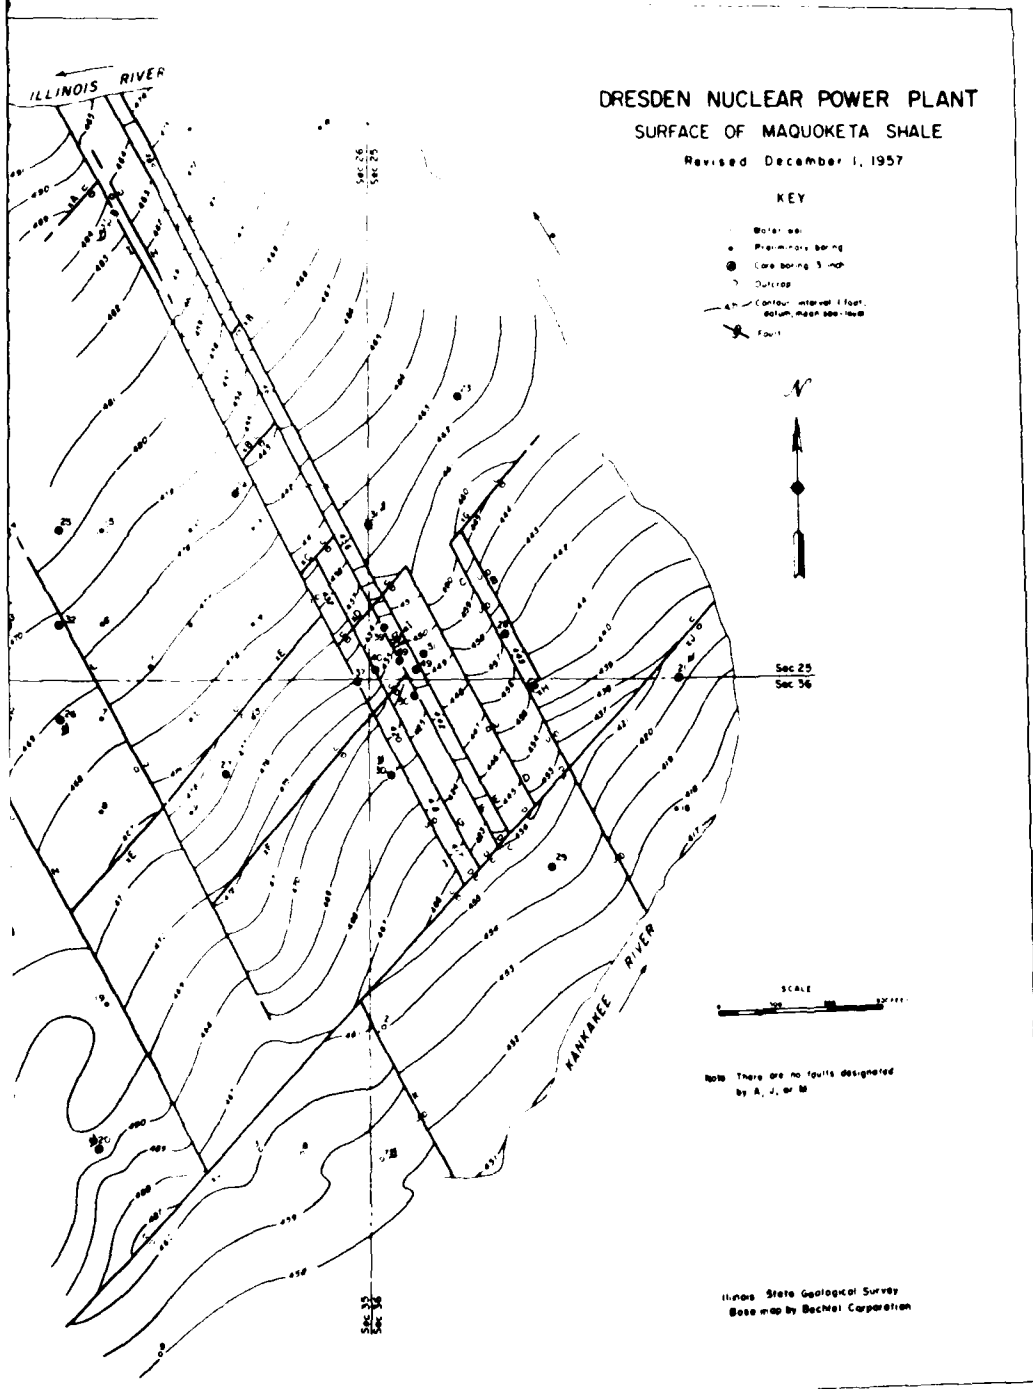
FIGURE 4

36. During the study to consolidate and evaluate engineering information, an aerial photograph of the Dresden Island Lock and Dam proved interesting. Figure 8 shows the lock, a part of the dam, and a portion of the nuclear power plant. The northwest trending line across the open pasture between the power plant and lock is believed to be the surface expression of a fault. A similar orientated fault line was interpreted by the Illinois Geological Survey; see Figure 4, fault L.

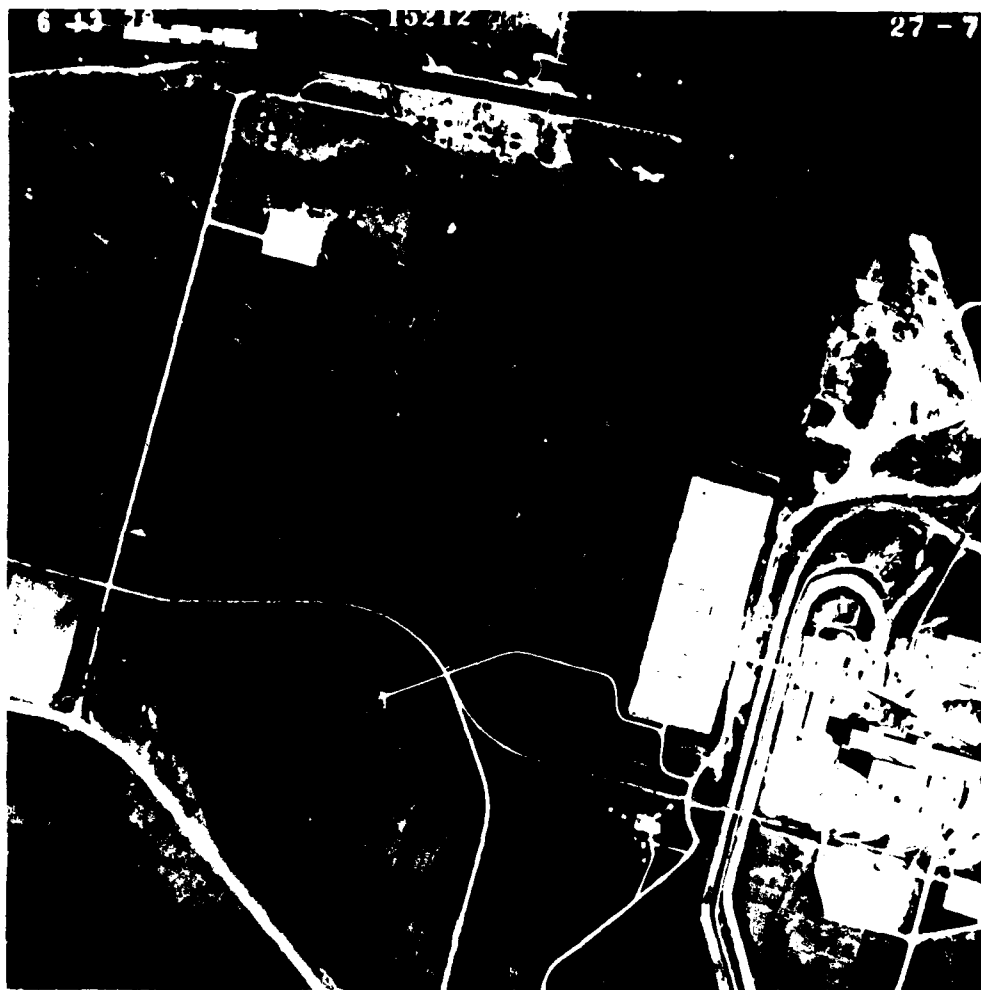
Figure 8. Air photograph, Dresden Island Lock and Dam and Dresden Nuclear Power Plant.

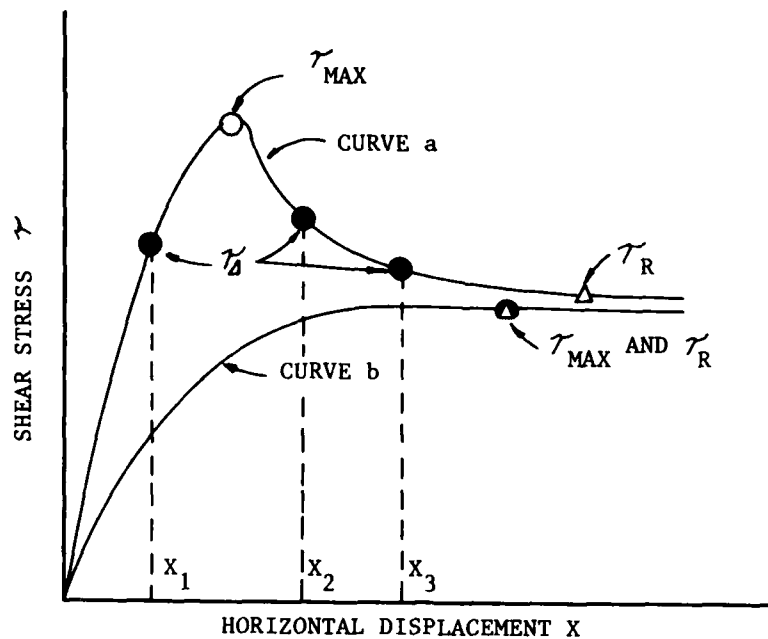
65. Designers are commonly interested in the maximum available shear strength. The maximum shear stress points are identified as τ_{max} in Figure 10. The maximum shear stress usually corresponds to the peak of the shear stress versus displacement plot (curve a of Figure 10); however, some confusion may arise where strain-hardening is encountered. When strain-hardening occurs, an initial peak usually occurs at a relatively small displacement, followed by an increase in shear stress to a value greater than the initial peak. When this happens, the first peak is termed the maximum shear stress corresponding to initial failure and the latter is the ultimate shear stress.

66. If the residual shear strength is to be determined, then displacement is continued until the shear stress approaches the horizontal asymptotic value of residual shear stress τ_R (curve a of Figure 10). When the zone tested exhibits only a residual shear strength, curve b of Figure 10 may be obtained. In such cases, the maximum shear stress attained is the residual shear strength. By testing a number of specimens, each at a different normal load, the maximum and residual strength failure envelopes are developed by plotting maximum and residual shear stresses versus corresponding normal stresses.

Figure 10. Maximum and residual shear stress, and displacement failure criteria, after Zeigler.

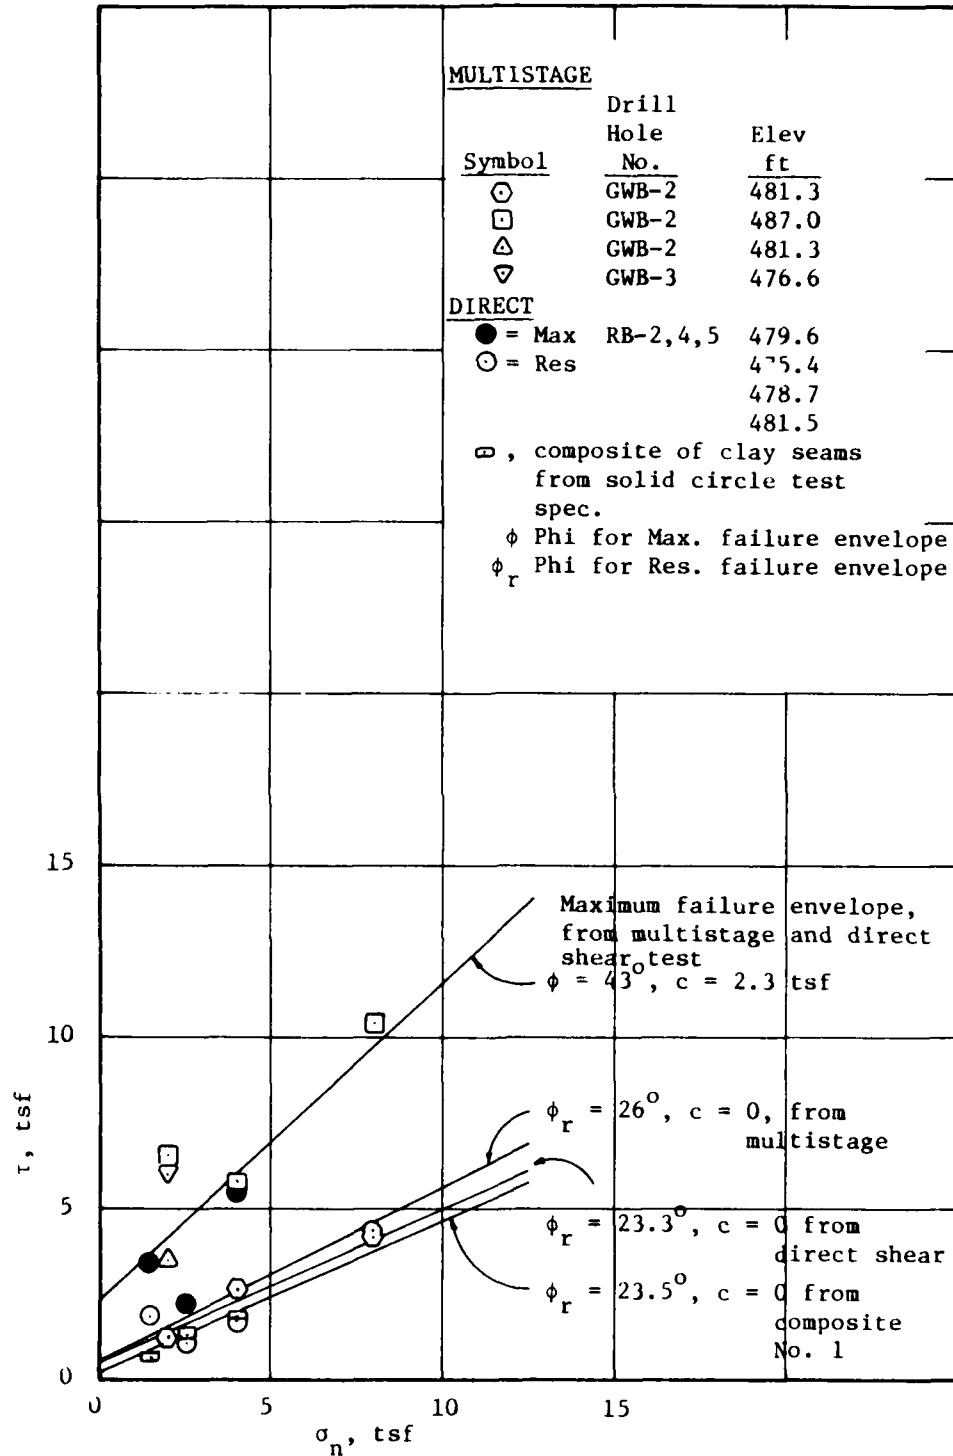
71. The failure envelopes for the critical zones within the foundation are presented in Figures 11 through 13. The critical zones in terms of sliding are the green clay layer at the base of the Ft. Atkinson and the clay and shale/clay filled partings in the Ft. Atkinson. The bedrock feature having the lowest residual strength is the green clay layer; residual strengths of $c = 0$ and $\phi_r = 12.5^\circ$ were obtained; see Figure 11. A conservative envelope was constructed by placing it through the lower data points and then shifting it to have a zero cohesion. The green clay layer exists beneath a section of the lower approach wall. It was not found beneath any other concrete at the site.

72. As mentioned earlier, multistage shear tests were conducted on filled parting specimens out of necessity. Direct shear tests were run for comparison. The direct shear testing shows that maximum strengths are higher than reported for the multistage tests. Maximum and residual strengths were obtained on the filled partings using the following test technique. Four specimens each were used for the two differently filled partings. Each of the four specimens had different normal loads applied; 1.5, 2.5, 4.0, and 8.0 tsf. A specimen was consolidated with a normal load, sheared, and a peak load determined. The shear and normal loads were removed, the specimen repositioned, the same normal load reapplied and sheared again. This sequence was continued with the same specimen until a residual strength was obtained. Another specimen was likewise tested at a greater normal load, and so forth. The peak and residual shear stress values from the four specimens were used to construct maximum and residual strength failure envelopes; thus, maximum and residual ϕ angles were determined; see Figures 11 and 12.

Figure 12. Direct shear results, clay seam in limestone.
